Thermal Nondestructive Evaluation Report - Inspection of the Refurbished Manipulator Arm System in the Manipulator Development Facility of Johnson Space Center 10-12 January 2001

NASA/TM-2002-211732

July 2002

K. Elliott Cramer
NASA Langley Research Center

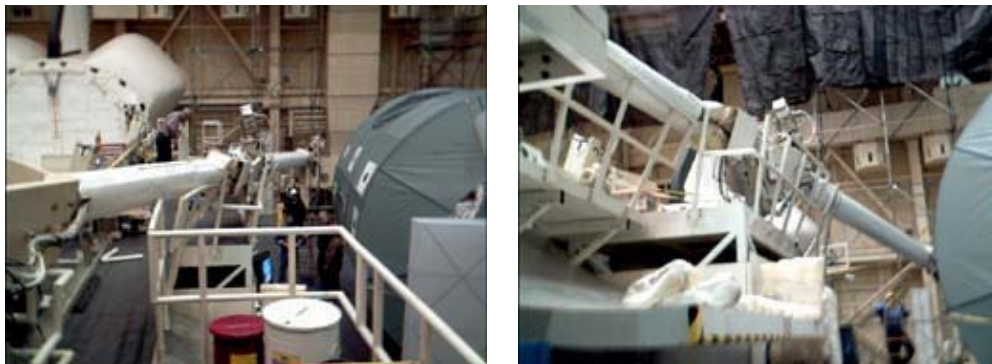
Figure 1 -- Incident photographs showing MDF Arm after yaw hydraulics failure

On 4 December 2000, after repairs were made to the robotic arm's shoulder yaw (SY) joint a hydraulics failure occurred while the MDF Test Director (TD), commanding the robotic arm from the Aft Cockpit, attempted to position the arm properly in the cradle position prior to beginning crew training. When the Test Director commanded a shoulder pitch maneuver to lift the arm from its payload bay pedestal, the yaw controls failed due to bleed valves not being closed properly. This, coupled with gravitational forces (due to the angle of the shoulder joint with respect to vertical), resulted in uncontrolled arm motion. The shoulder yaw joint moved approximately 20 degrees, causing the extended arm to strike (and severely damage) the port side MDF catwalk handrails. The arm motion stopped after impact with the handrails (See Figure 1).

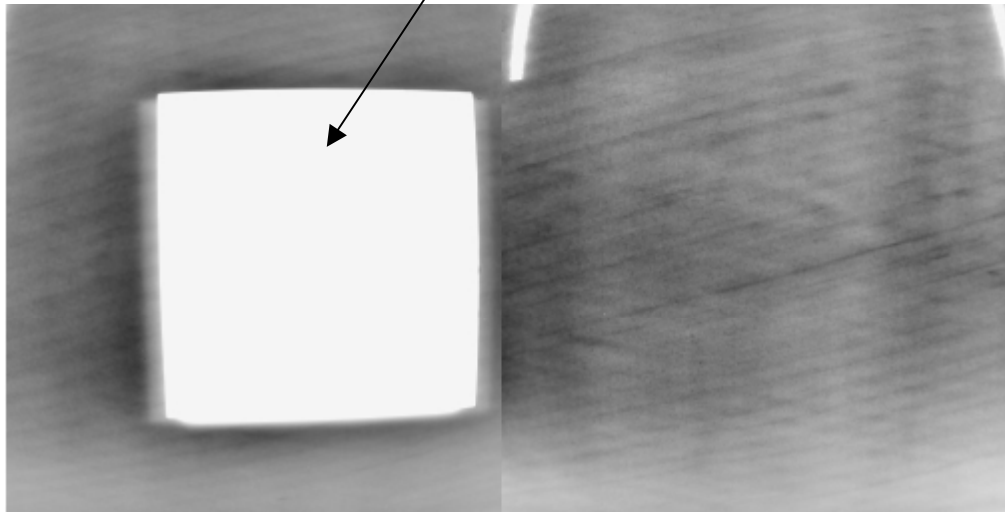
Figure 6 -- Location #1 (No Indications Recorded)

Location #1 (Figure 6):

No indications of material degradation were recorded in the thermal inspection. Note that the fiber lay-up is clearly visible in this image.

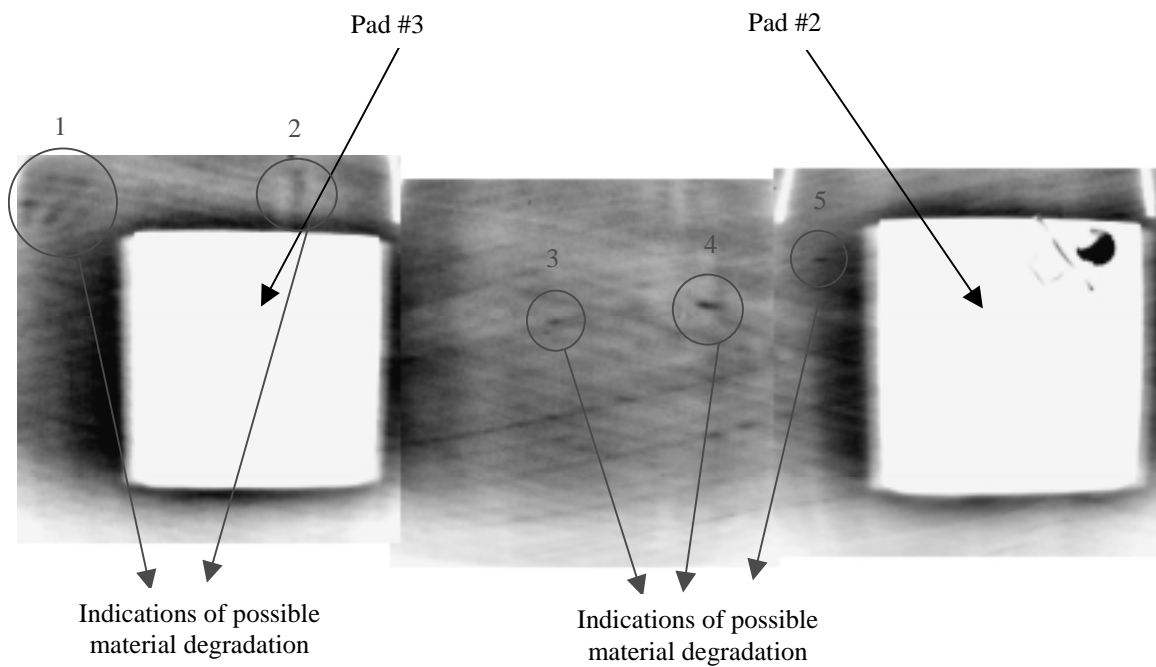
Figure 7 -- Location #2

Location #2 (Figure 7):

Several small indications were recorded, especially between pad #2 and pad #3. These indications are consistent with a reduction in thermal heat flow into the material,

which could be due to a number of factors such as porosity, resin rich regions or localized delaminations[#].

The two indications above pad #3 are also consistent with a reduction in thermal heat flow, but are of a larger extent. The time resolved data reveals that these indications appear to be limited in extent to very close to the surface.

Indication Sizes:

#1 – 1.4 in. wide x 1.1 in. high

#2 – 0.9 in. wide x 0.8 in. high

#3 – 0.3 in. long

#4 – 0.4 in. long

#5 – 0.35 in. long

[#] Note: These small indications are seen throughout the upper and lower arm, even in areas where no impact is suspected, which may indicate that they are a result of the manufacture of the structure.

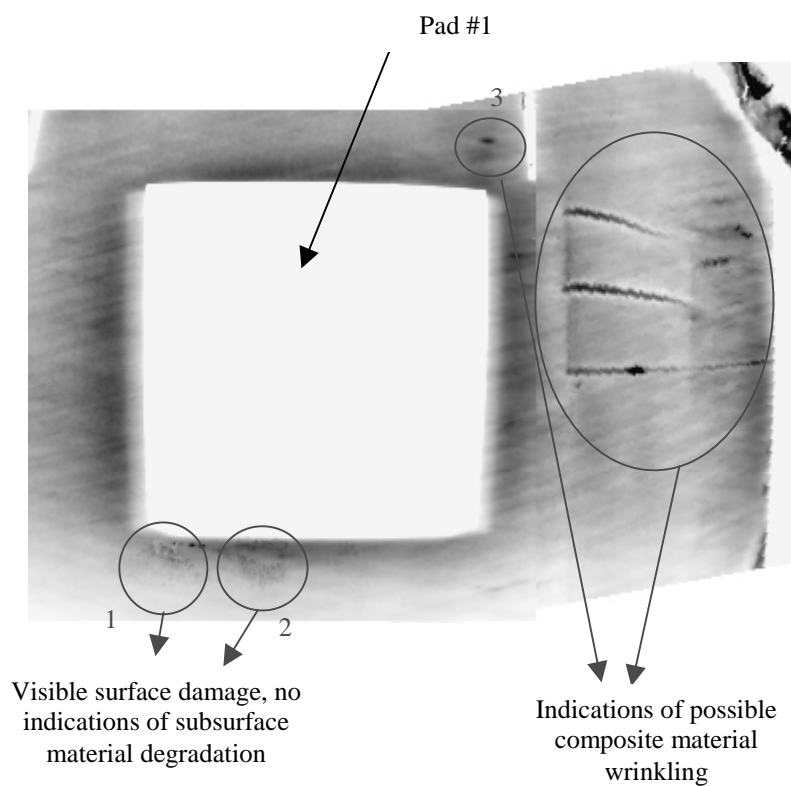
Figure 8 --Location #3

Location #3 (Figure 8):

Directly below pad #1 the visible surface damage can also be seen in the IR images. This damage appears to be limited in extent to the near surface region and does not display thermal characteristics of impact damage that has resulted in subsurface delaminations.

Between pad #1 and the elbow indications were observed which are consistent with wrinkles in the composite material.

Additionally, just above the right corner of pad #1 is a small indication[#] consistent with those seen throughout both the upper and lower arms (see note on location #2).

Indication Sizes:

#1 – 0.9 in. wide x 0.6 in. high

#2 – 0.8 in. wide x 0.7 in. high

#3 – 0.32 in. long

Note: It was not possible to make measurements of the size of the wrinkles because of the large camera angle required to access this location.

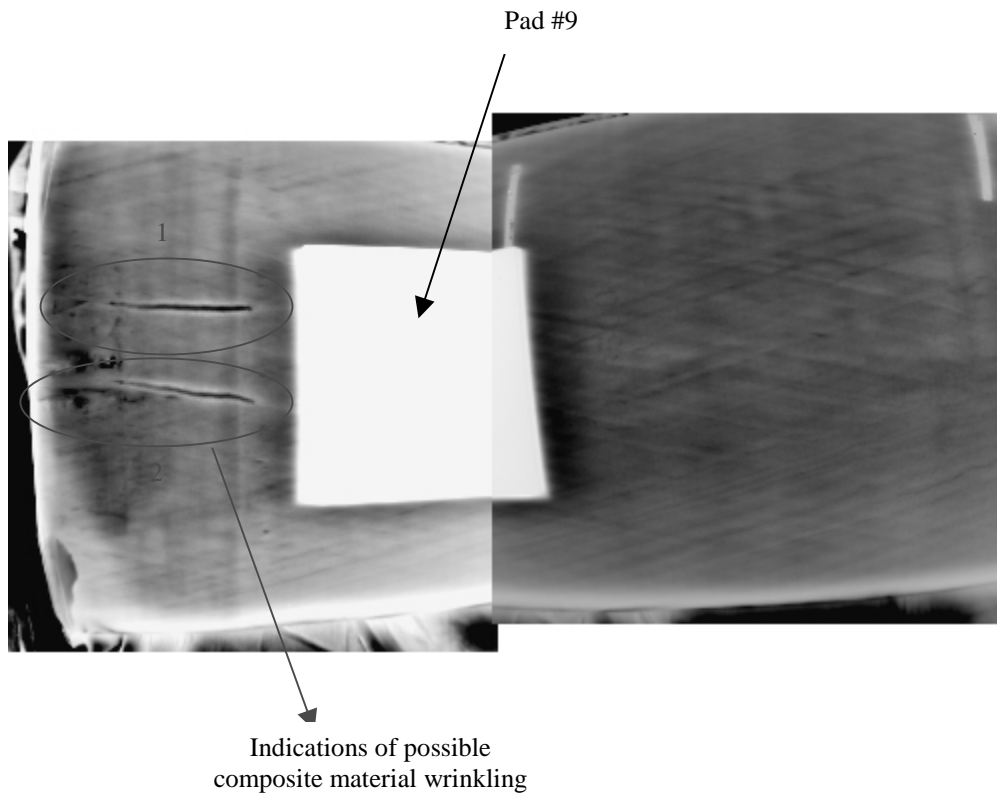
Figure 9 -- Location #7

Location #7 (Figure 9):

Between pad #9 and the shoulder indications were observed which are consistent with wrinkles in the composite material as seen in Location #3.

Indication Sizes:

- #1 – 2.8 in. long
- #2 – 3.8 in. long

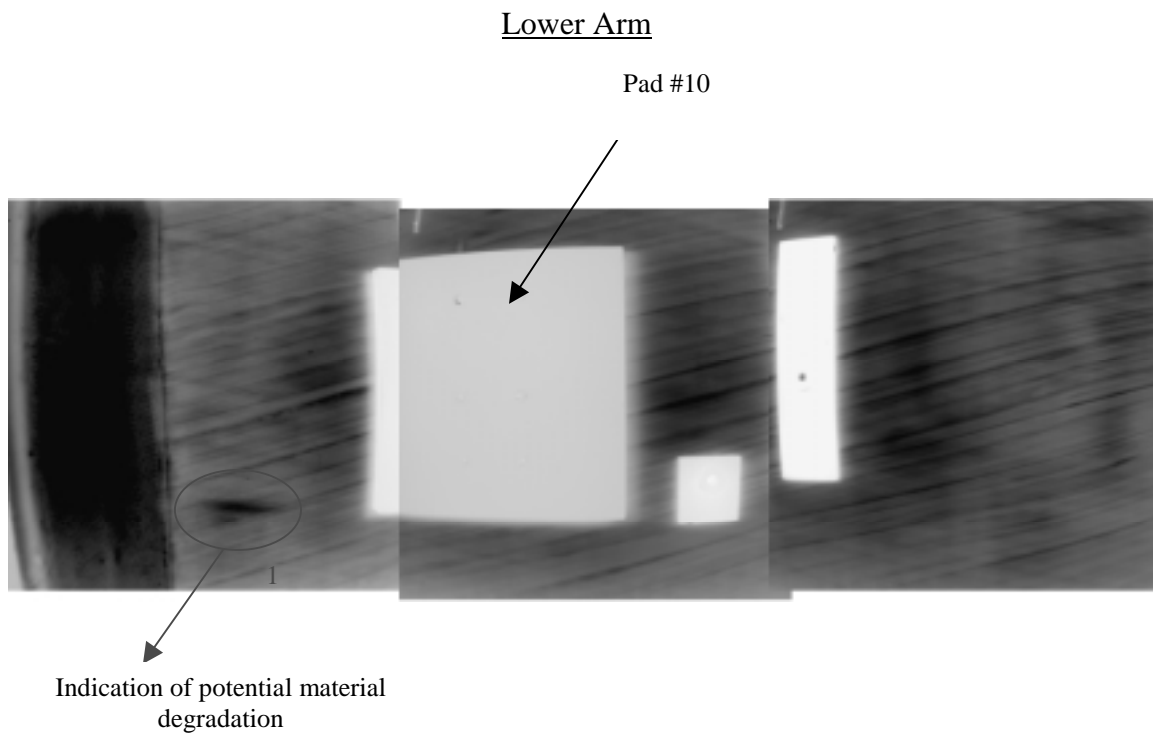
Figure 10 -- Location #4

Location #4 (Figure 10):

One indication was recorded between pad #10 and the elbow. This indication (although larger) is consistent with the small indications[#] seen throughout both arms (see note on location #2).

Indication Sizes:

#1 – 1.35 in. wide x 0.3 in. high

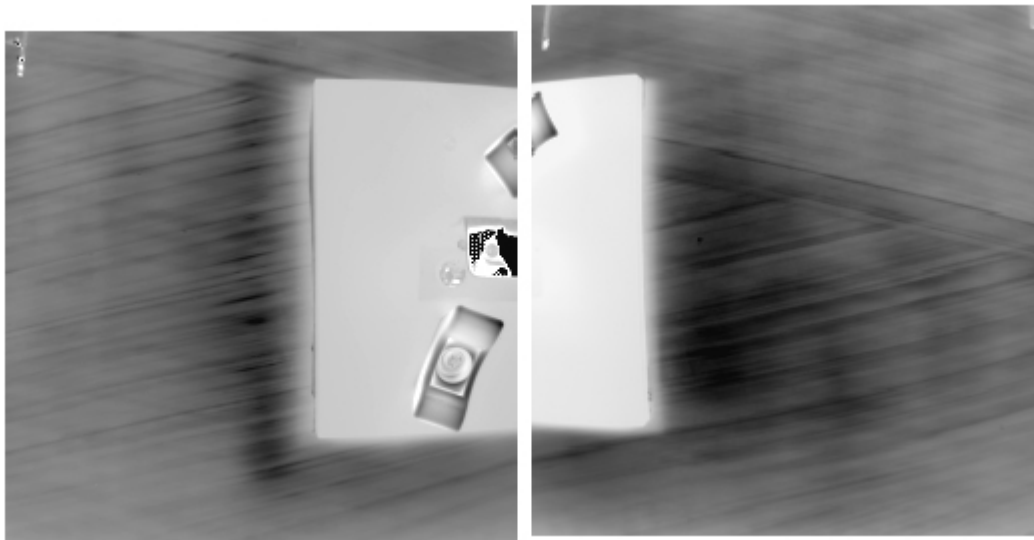
Figure 11 -- Pad #9 No Indications (Recorded for Reference)

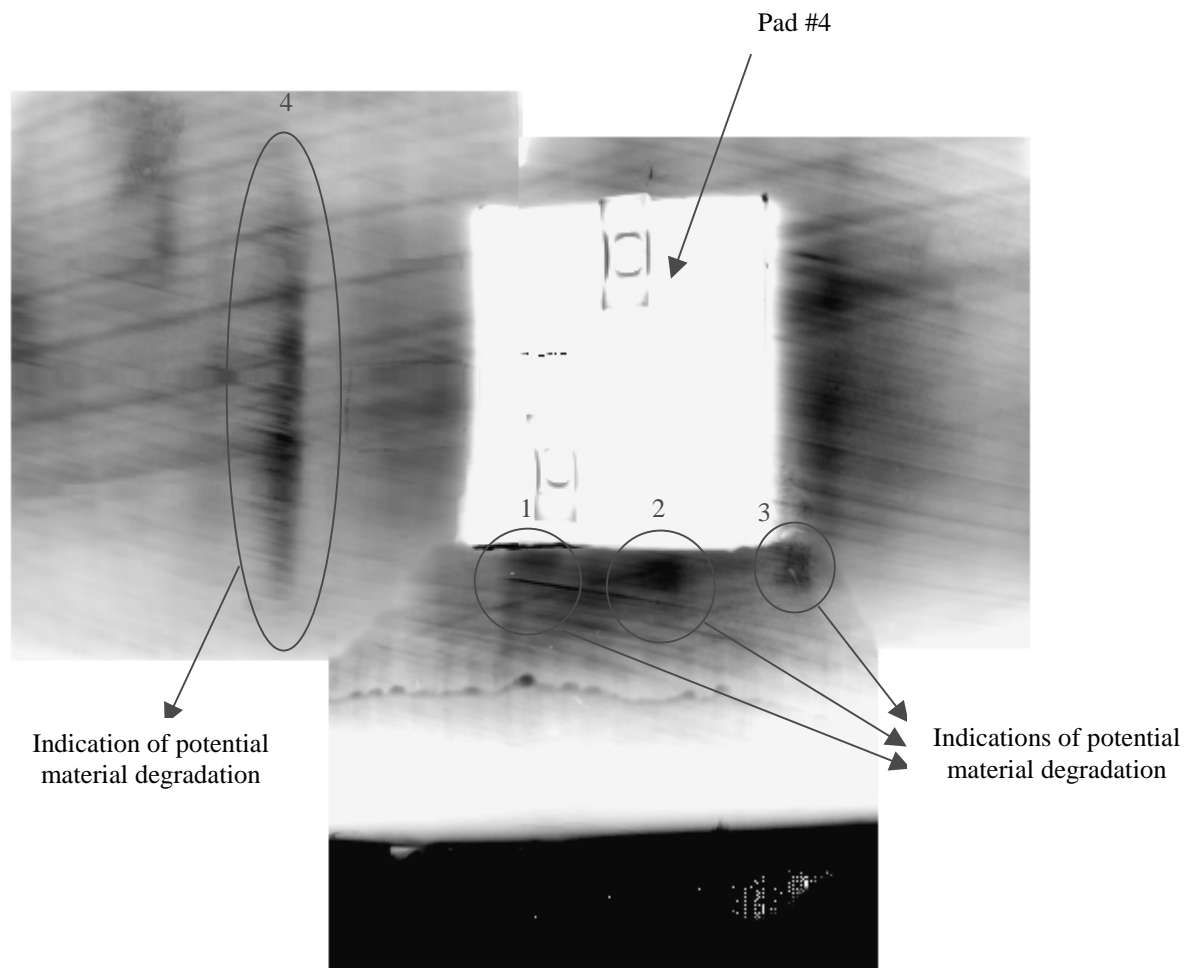
Figure 12 -- Locations #5 & #9

Locations #5 & #9 (Figure 12):

A number of significant indications were observed in these locations. First, a large vertical indication parallel and to the left of pad #4 was observed. This indication appears to extend quite deep into the material (at least through ½ the thickness) and also tends to spread parallel to the fibers. Again this is a region that does not allow good propagation of the heat flux and could be attributed to porosity, dry fibers (resin poor regions) or delaminations.

Another series of indications were recorded directly below pad #4. These indications do not appear to follow the fiber layup and also extend quite deep into the material.

Indication Sizes:

- #1 – 0.8 in. wide x 0.5 in. high
- #2 – 0.8 in. wide x 0.6 in. high
- #3 – 0.5 in. wide x 0.8 in. high
- #4 – 0.8 in. wide x 6.25 in. high

Certain areas (Locations 5, 8 and 9) showed indications unique enough to warrant further investigation of these with other techniques such as conventional and advanced ultrasound or x-ray.

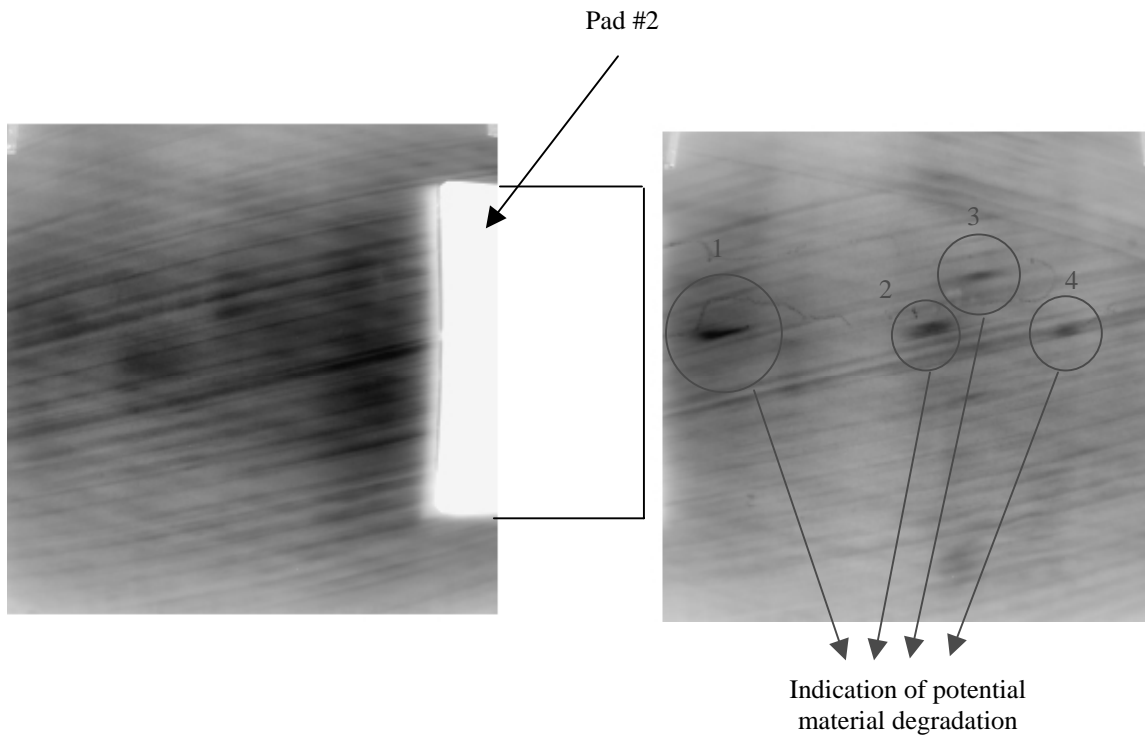
Figure 13 -- Location #6

Location #6 (Figure 13):

Four indications were recorded between pad #2 and pad #1. These indications are consistent with the small indications[#] seen throughout both arms (see note on location #2).

Indication Sizes:

- #1 – 1.7 in. wide x 0.3 in. high
- #2 – 0.8 in. wide x 0.3 in. high
- #3 – 0.8 in. wide x 0.2 in. high
- #4 – 0.4 in. wide x 0.3 in. high

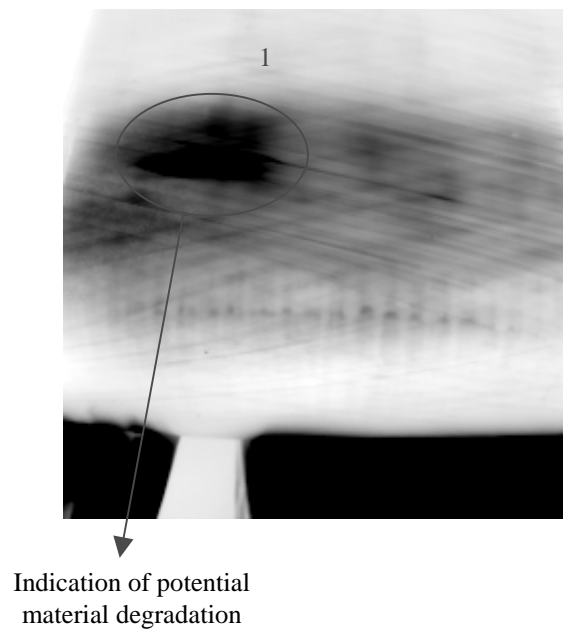
Figure 14 -- Location #8

Location #8 (Figure 14):

Between pads #7 & #8 a single indication was observed which is consistent with impact damage indications that have been observed in other composite materials. This indication is fairly localized on near the surface, but appears to grow in size deeper into the material.

Indication Sizes:

#1 – 2.2 in. wide x 0.6 in. high
